YOUR INSPECTION REPORT

658 Clarke Rd
Coquitlam , BC

Monday, April 20, 2015

RE: Report No. 2583
658 Clarke Rd
Coquitlam , BC

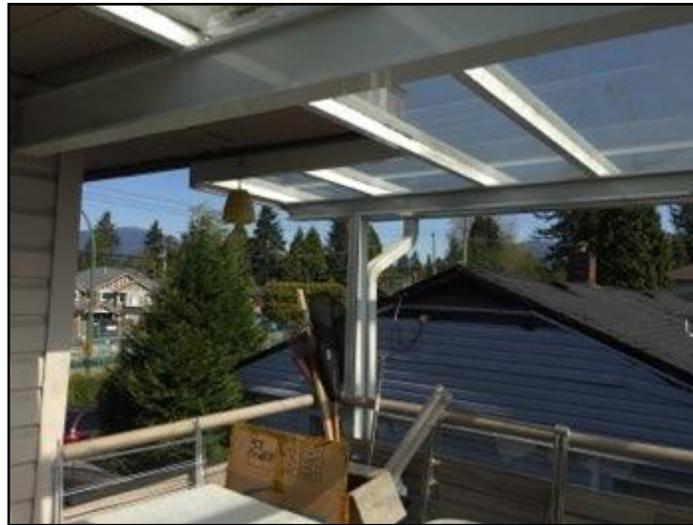
8. Area has been added on. Ask for building...

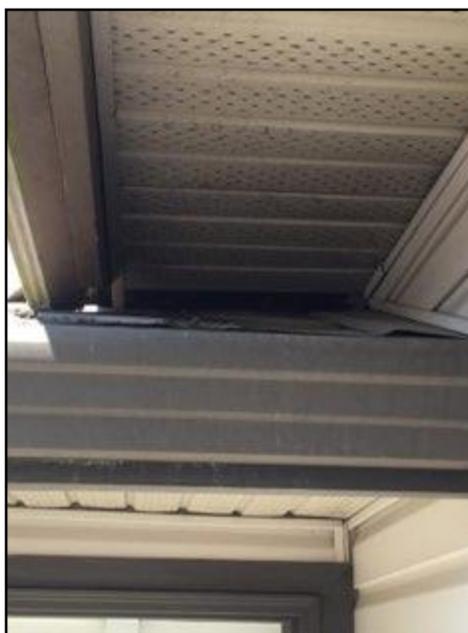
3. **Condition:** • [Loose or missing pieces](#)

Implication(s): Cosmetic defects | Chance of water damage to contents, finishes and/or structure | Chance of pests entering building

9. Loose or missing pieces

Task: Repair

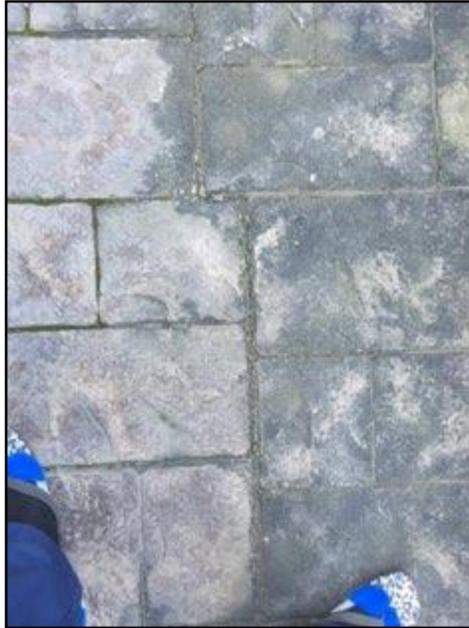
4. Condition: • Missing sealants at deck areas

10. Missing sealants at deck areas

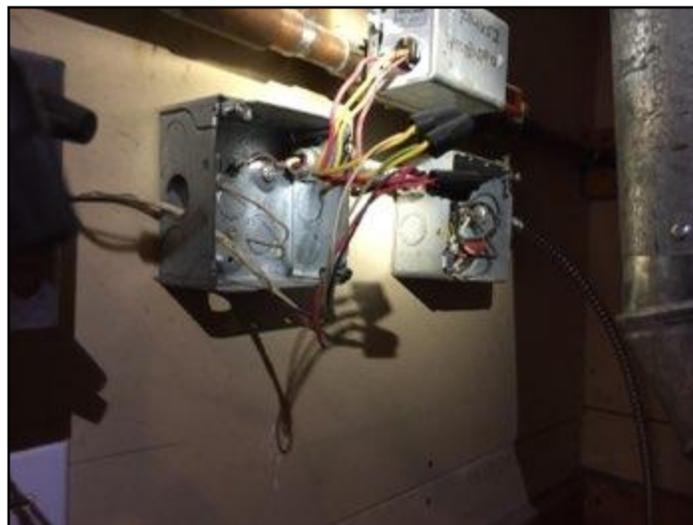
6. Condition: • [Missing, loose](#)

Implication(s): Electric shock | Fire hazard

15. Missing, loose

Task: Repair

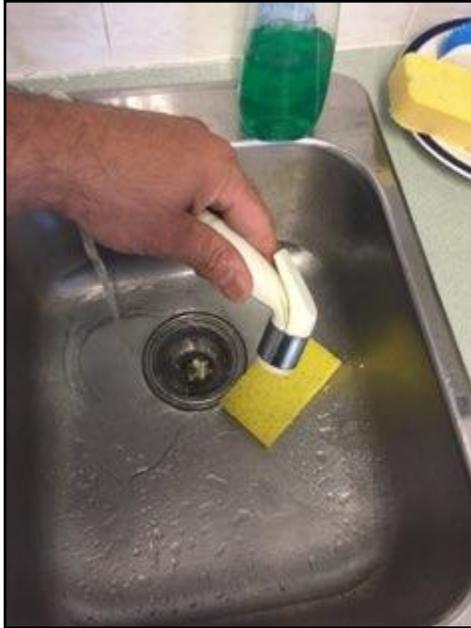
14. Condition: • [Drip, leak](#)

Implication(s): Chance of water damage to contents, finishes and/or structure

32. Drip, leak

Task: Repair

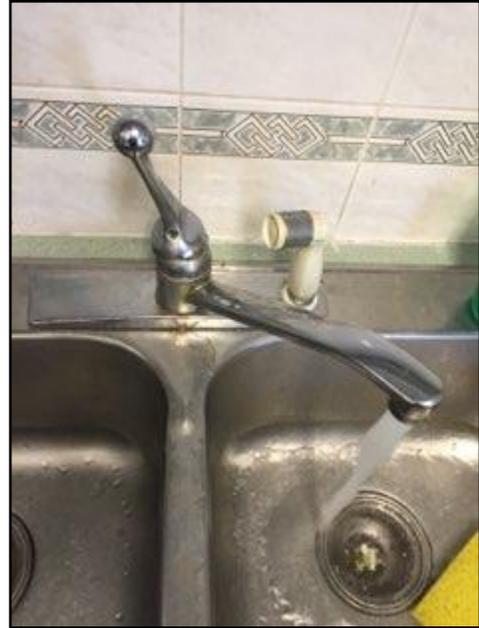
33. Drip, leak

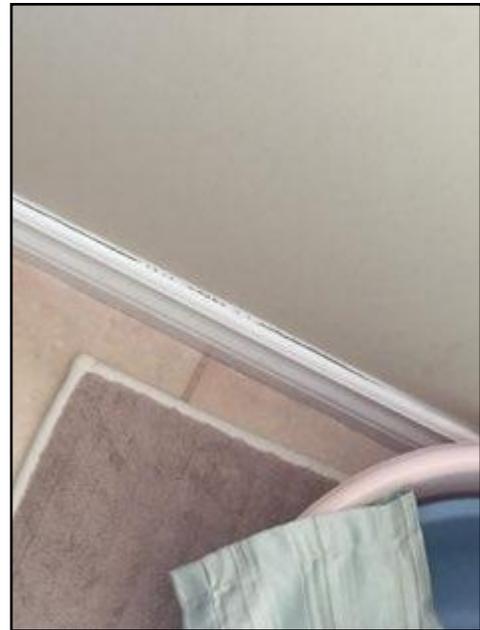
44. Service sealants

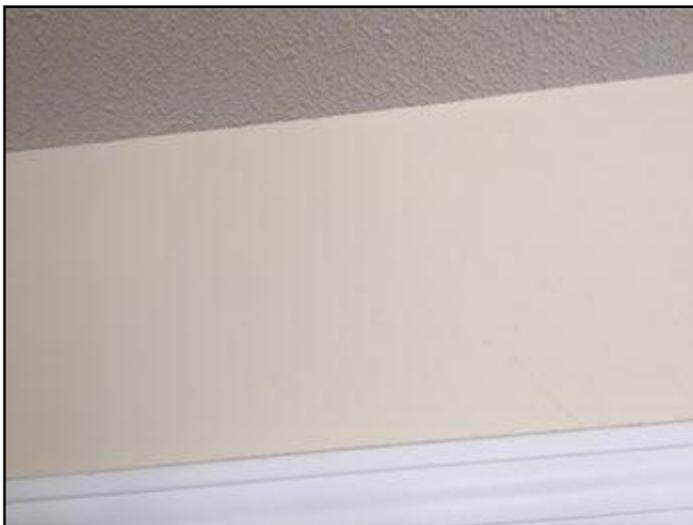
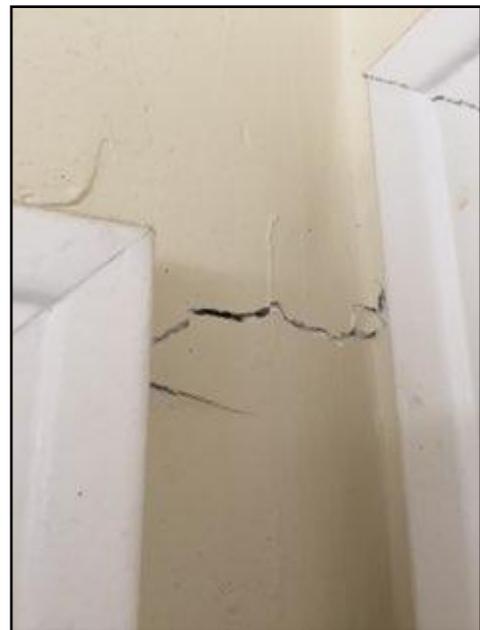
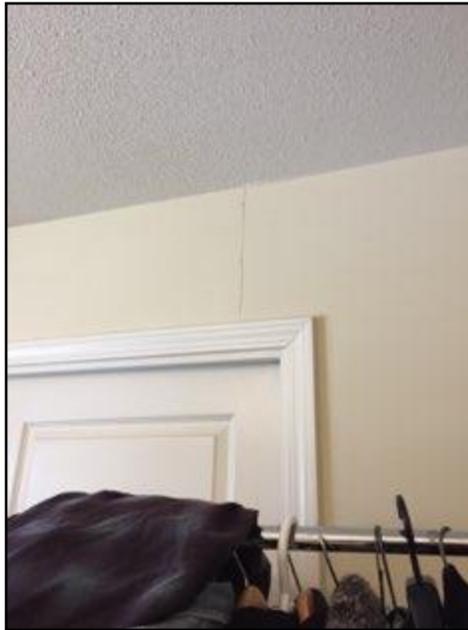
18. Condition: • [Cracked](#)

Implication(s): Cosmetic defects

50. Cracked

51. Cracked

52. Cracked

Task: Service

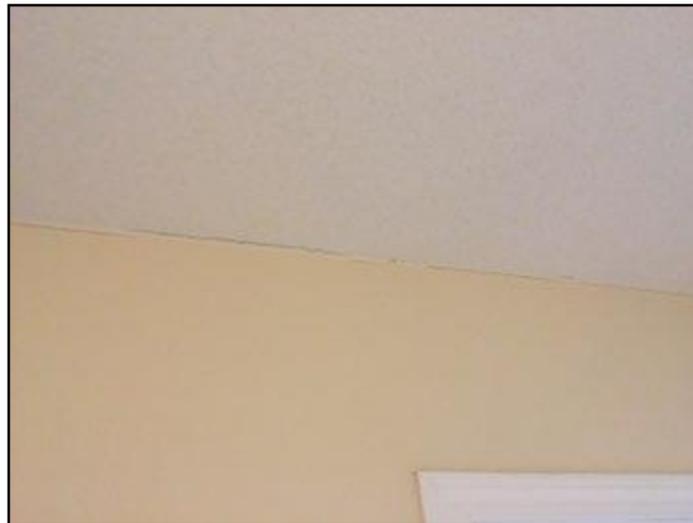
19. Condition: • [Cracked](#)

Implication(s): Cosmetic defects | Damage or physical injury due to falling materials

53. Cracked

Task: Service

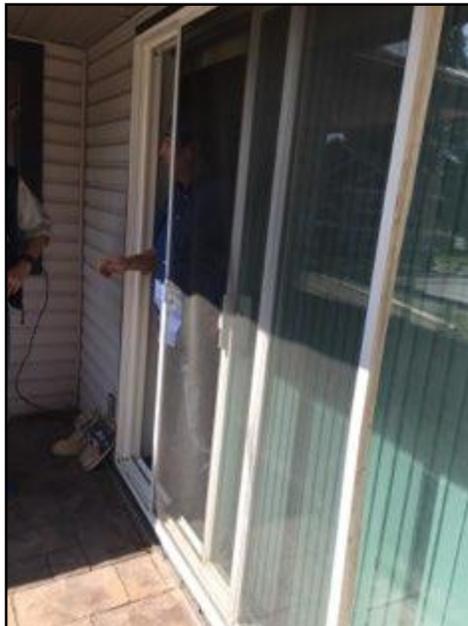
21. **Condition:** • [Rust](#)

55. Rust

Task: Repair or replace

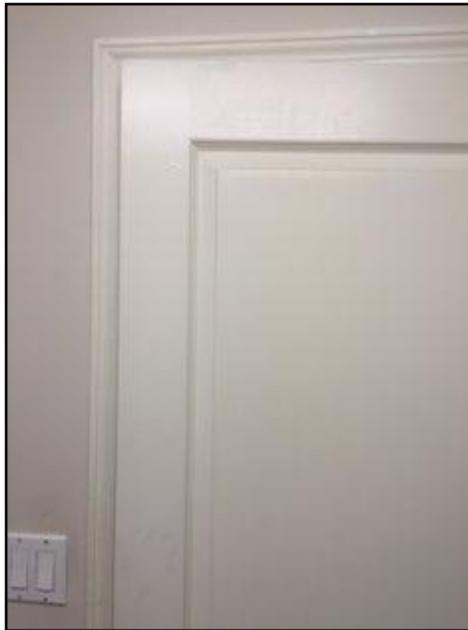
22. Condition: • [Stiff](#)

56. Stiff

Task: Repair

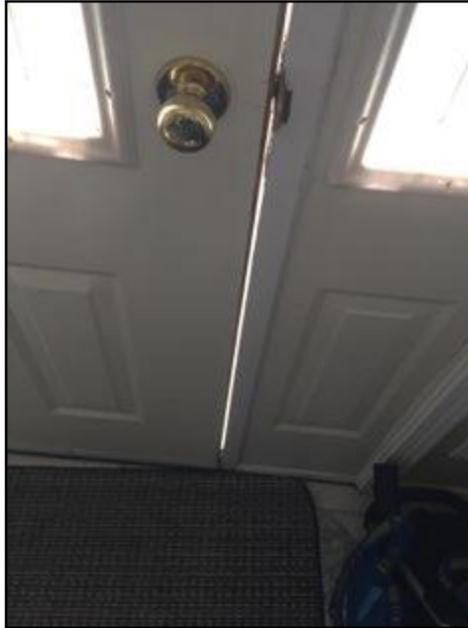
23. Condition: • [Weatherstripping missing or ineffective](#)

57. Weatherstripping missing or ineffective

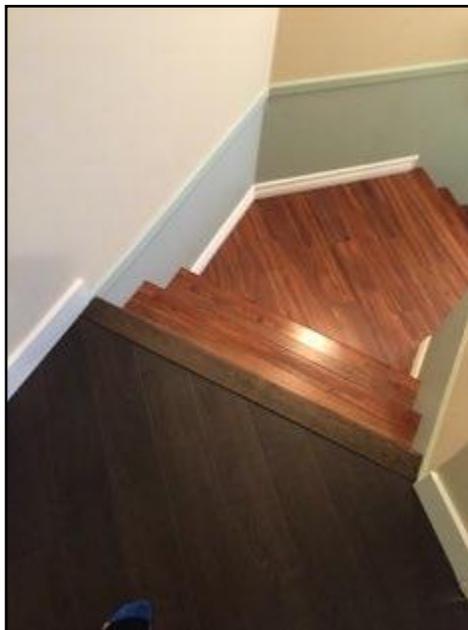
25. Condition: • [Missing](#)

59. Missing

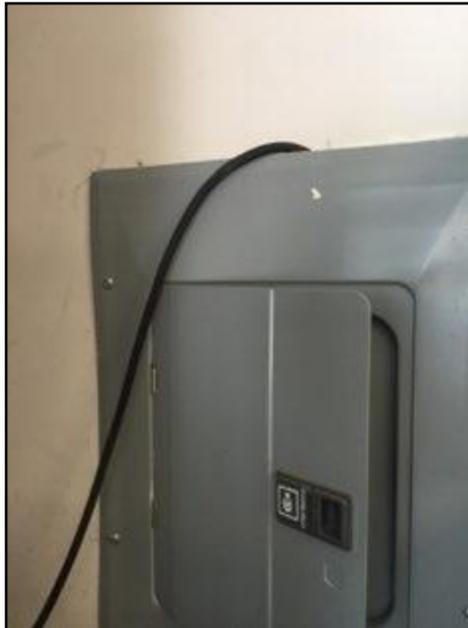
72.

30. **Condition:** • Unprotected wire run right out of panel

Implication(s): Electrical hazard

Task: Repair

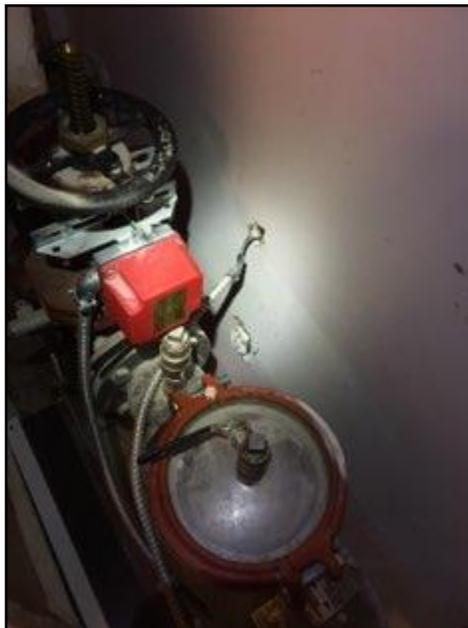
73.

31. Condition: • Exposed wire at wall area. Missing outlet cap.

Implication(s): Safety hazard

Task: Repair

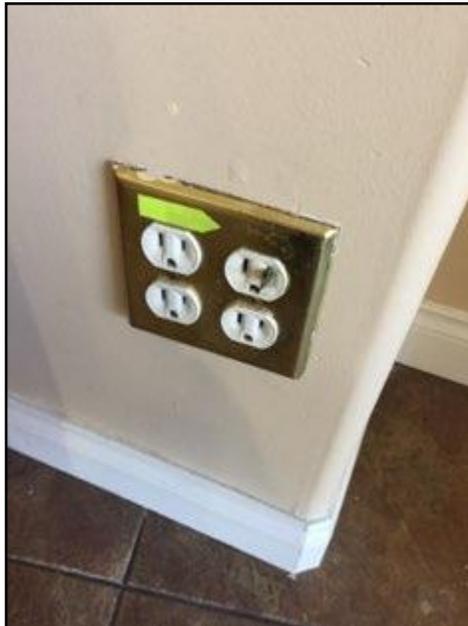
77.

34. Condition: • Damaged plug

Implication(s): Fire hazard

Task: Repair

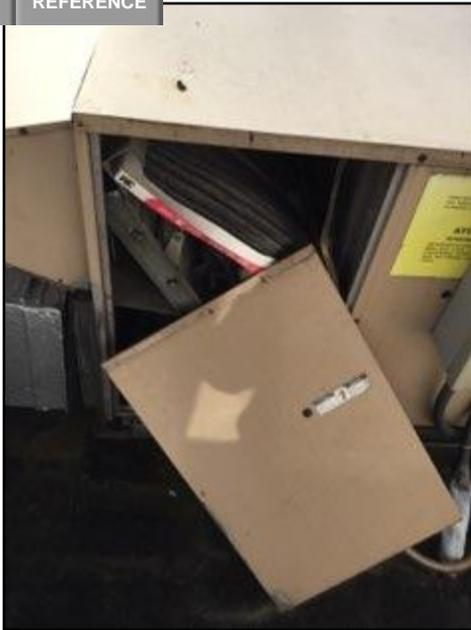
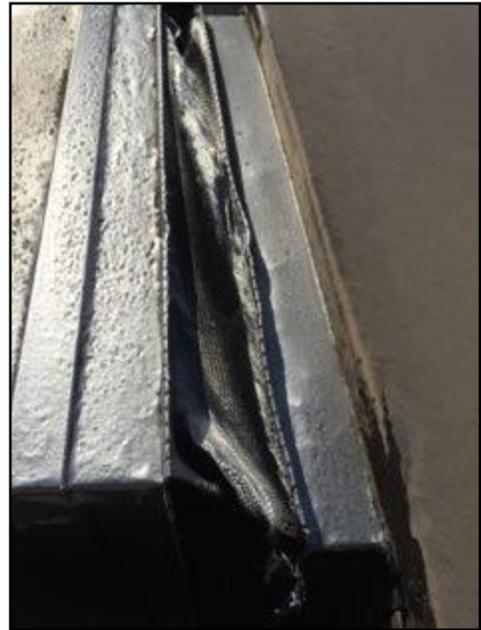
39. Condition: • The Air-conditioning system has not been well maintained.

Deterioration in connections between ductwork

80. The Air-conditioning system has not been...

81. The Air-conditioning system has not been...

Task: Repair

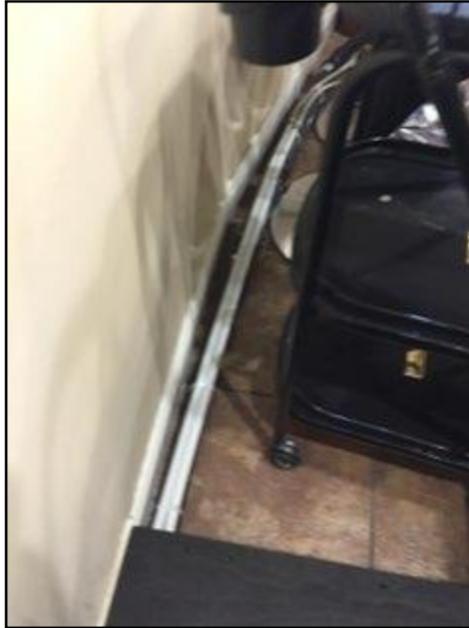
90.

43. Condition: • Supply plumbing susceptible to damage

Implication(s): Water damage and or extra costs can occur

Task: Repair

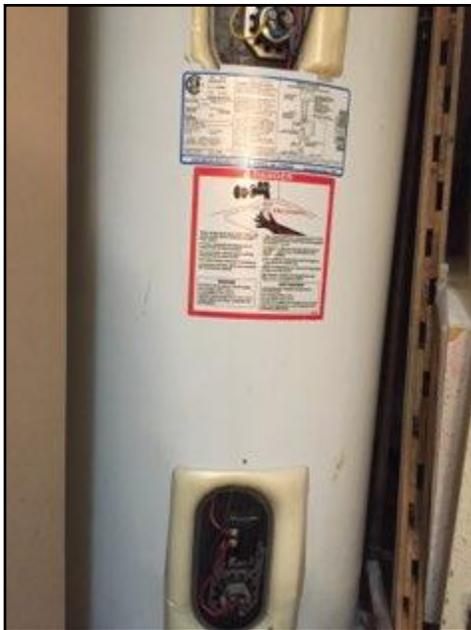
44. Condition: • Approaching the end of its expected useful life

91. Approaching the end of its expected useful...

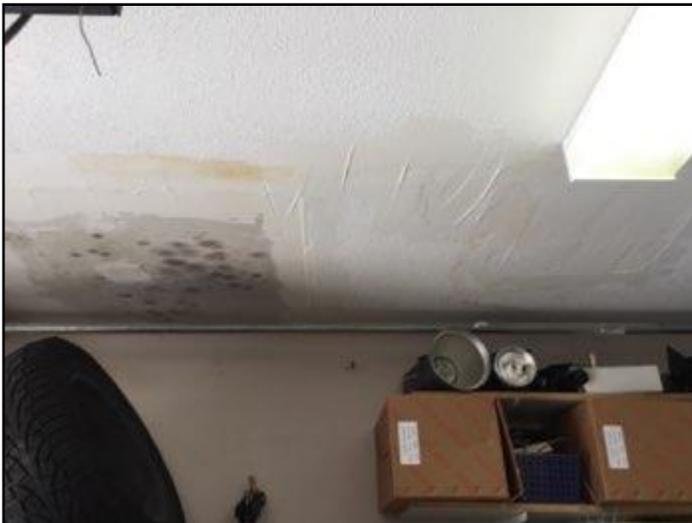
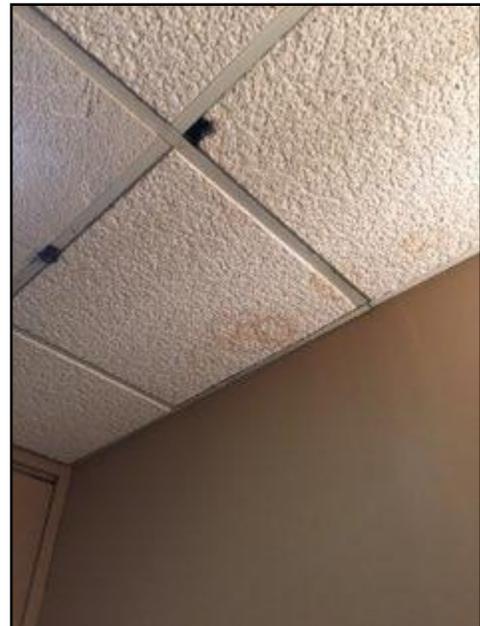
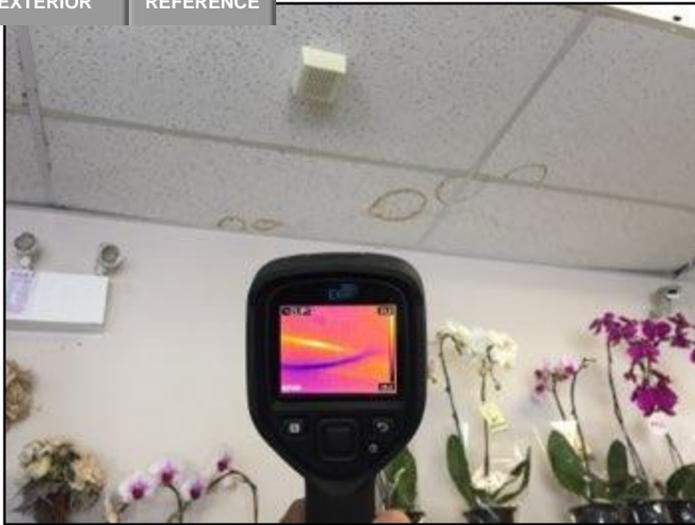
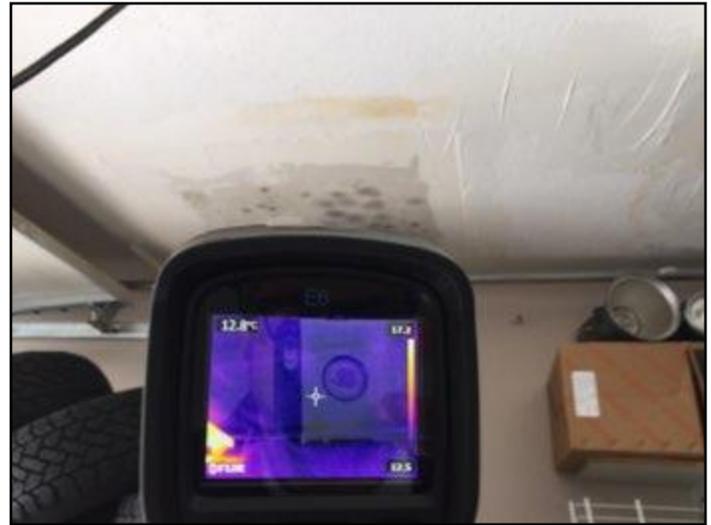
60. Condition: • Water stain

132. Water stain

133. Water stain

134. Water stain

135. Water stain

Task: Monitor

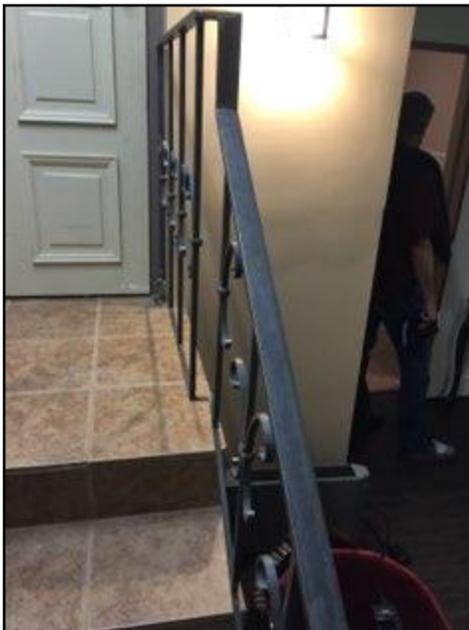
63. **Condition:** • Loose

136. Loose

Task: Repair

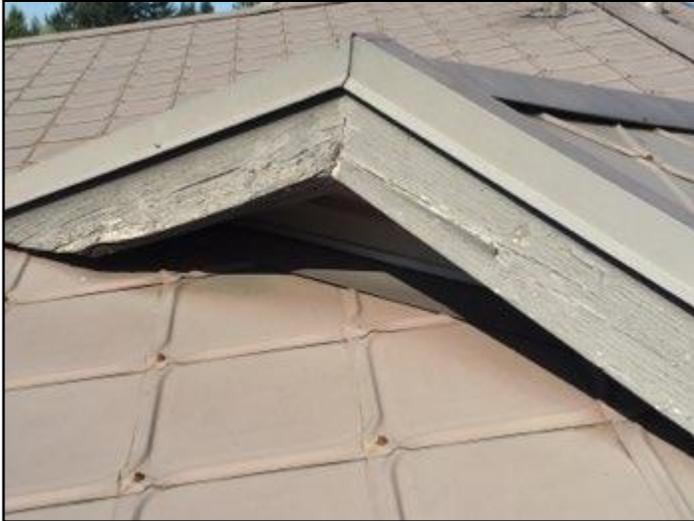
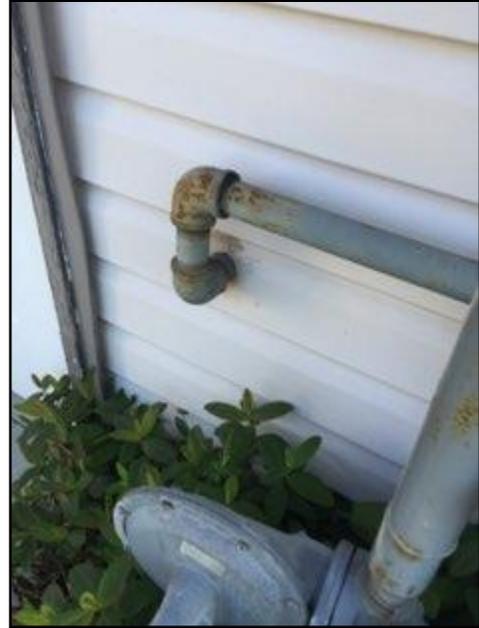
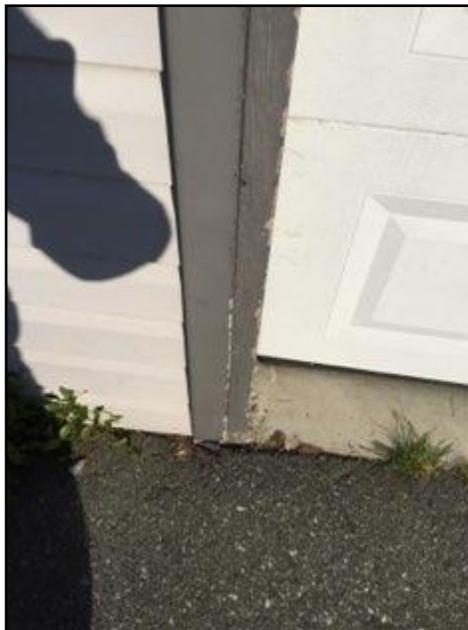
67. Condition: • Some deferred maintenance was noted.

148. Some deferred maintenance was noted.

149. Some deferred maintenance was noted.

150. Some deferred maintenance was noted.

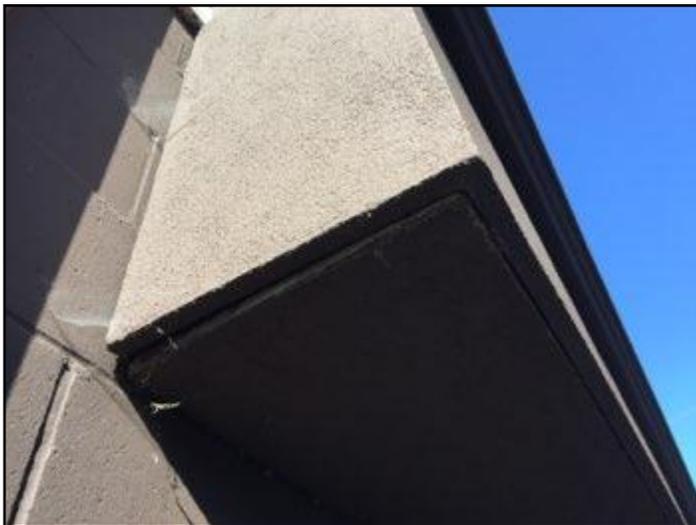
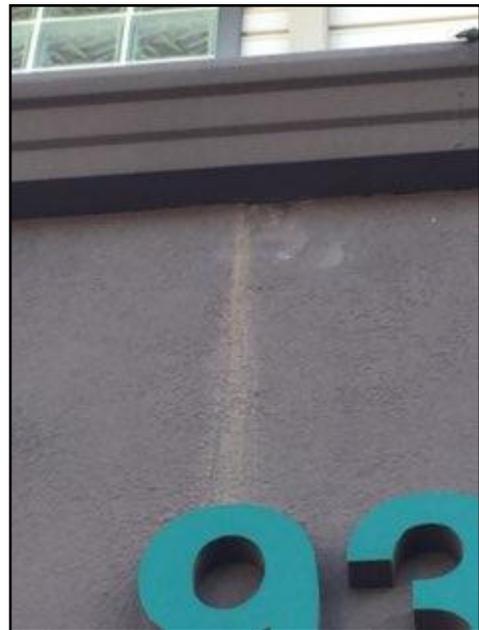
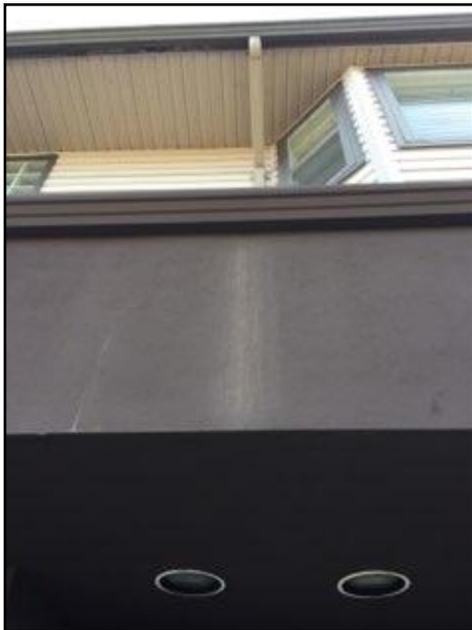
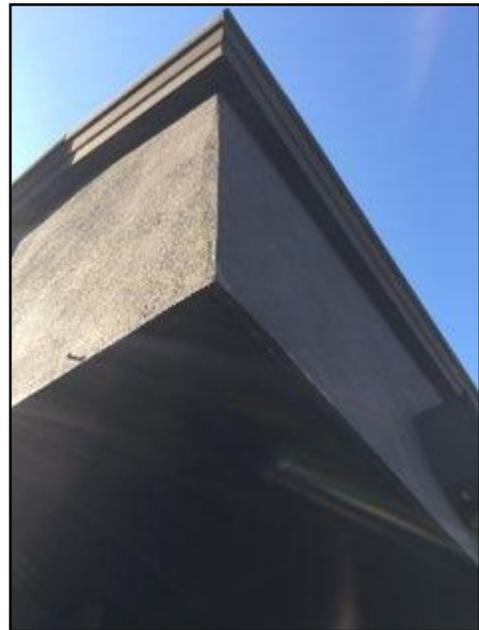
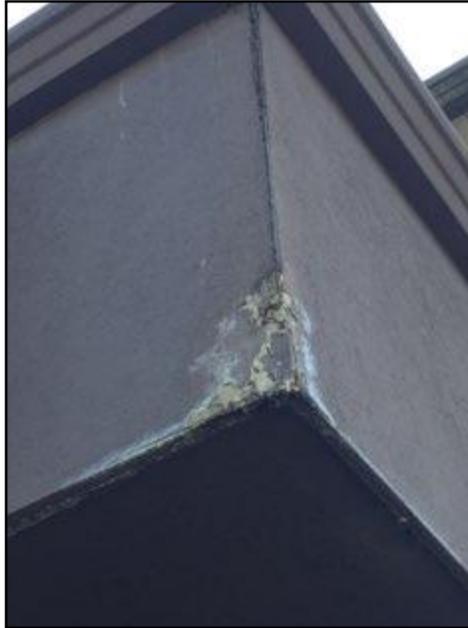
151. Damaged

152. Damaged

153. Damaged

154. Damaged

155. Damaged

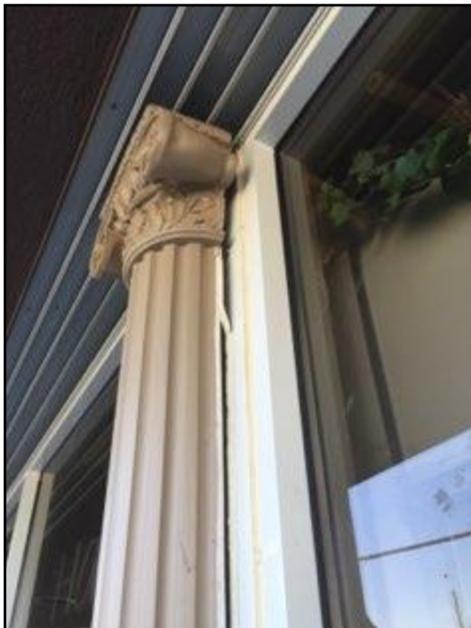
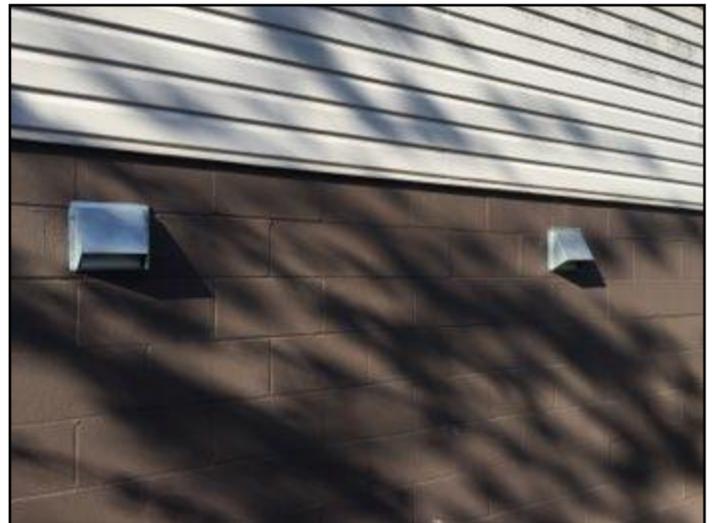
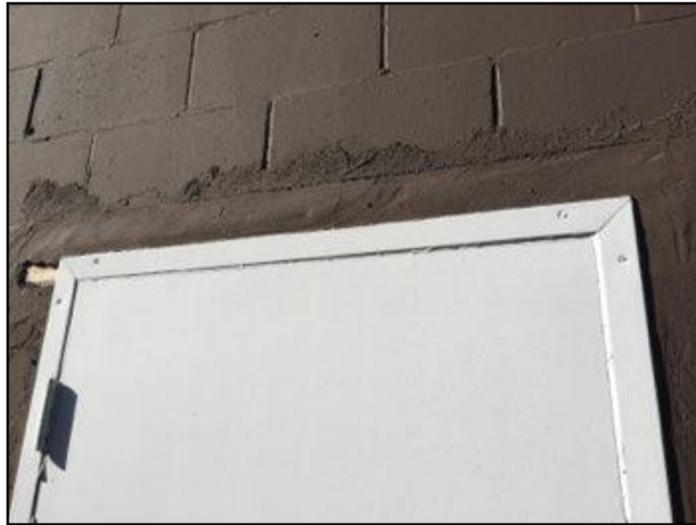
157. Deteriorated caulking

158. Deteriorated caulking

159. *Deteriorated caulking*

Task: Improve

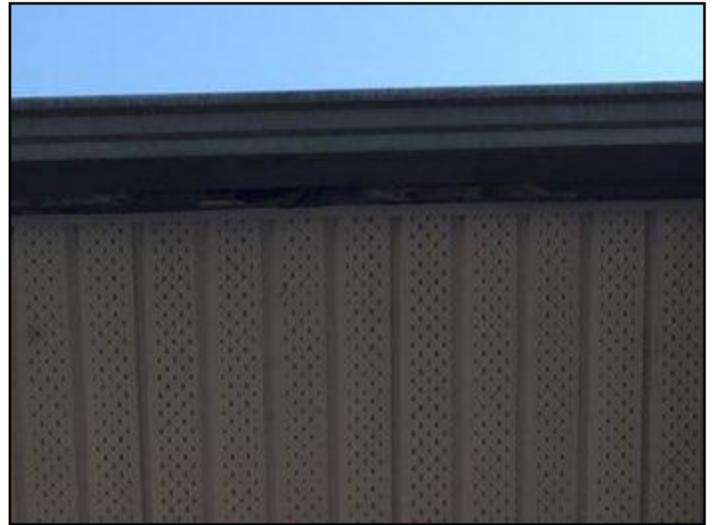
73. Condition: • Rotted

162. Rotted
