INSPECTION REPORT

For the Property at:
27 MAPLE CRESCENT
CHICAGO, IL

Prepared for: JOHN SIMPSON
Inspection Date: Saturday, December 16, 2006
Prepared by: Alan Carson

RE: Report No. 1366
27 Maple Crescent
Chicago, IL

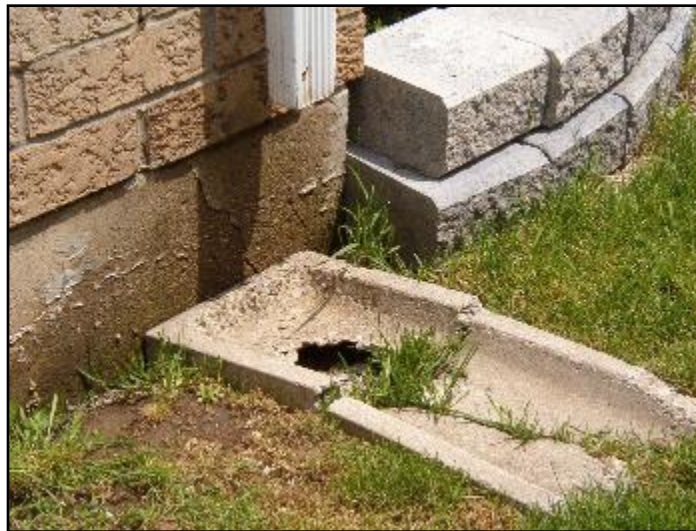
Condition: • [Downspouts end too close to building](#)

Implication(s): Chance of water damage to contents, finishes and/or structure

3. Downspout should be extended away from home

Note: The downspout should be extended to discharge at least 6 feet from the home. The broken splash block can be discarded.

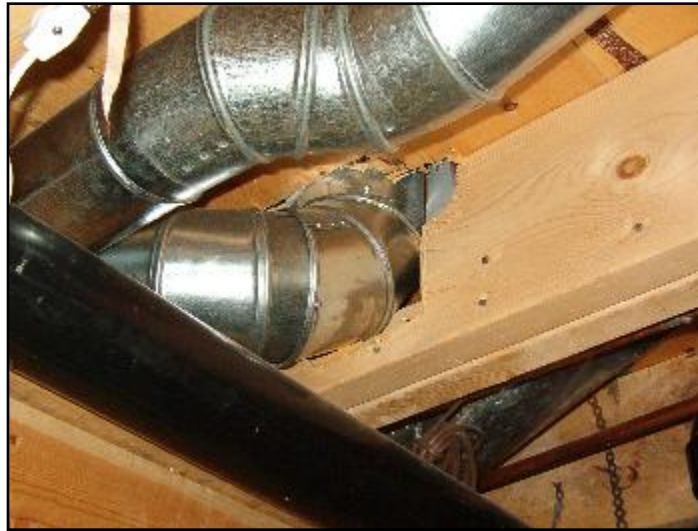
Condition: • [Notches or holes](#)

Implication(s): Weakened structure

4. Double joist cut for ductwork

Task: Replace

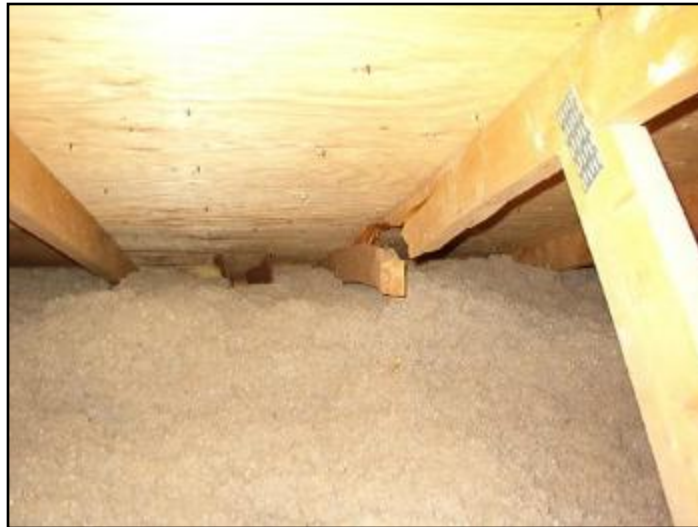
Condition: • [Split](#)

Implication(s): Weakened structure | Chance of structural movement

5. Top chord of truss is broken

Task: Repair or replace

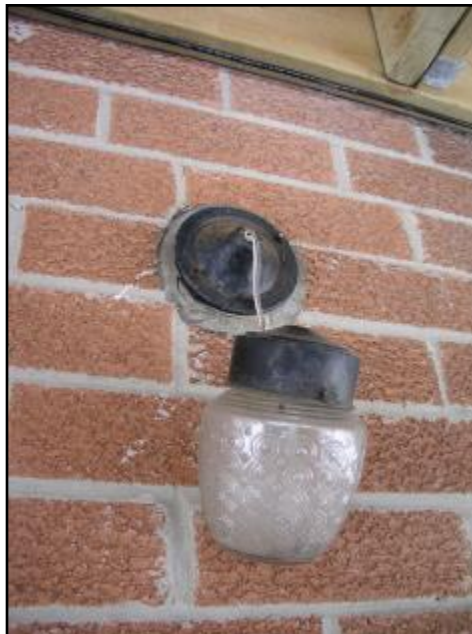
Condition: • [Loose](#)

Implication(s): Electric shock | Fire hazard

7. Light fixture is not well secured

Task: Repair or replace

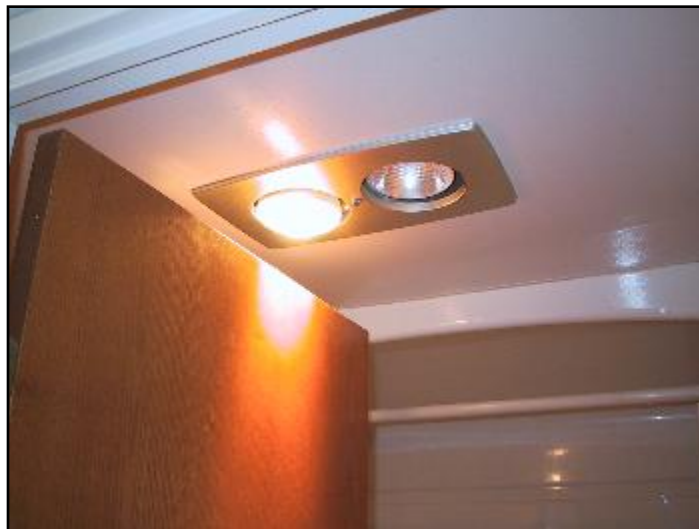
Condition: • [Heat lamps over doors](#)

Implication(s): Fire hazard

8. Heat lamp over door - fire hazard!

Task: Correct

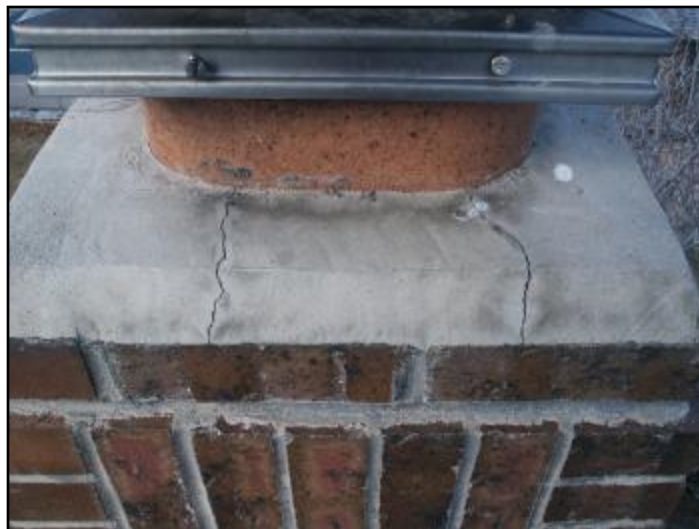
Condition: • [Cracked](#)

Implication(s): Chance of water damage to contents, finishes and/or structure | Shortened life expectancy of material

12. Minor cracks in chimney cap

Task: Repair

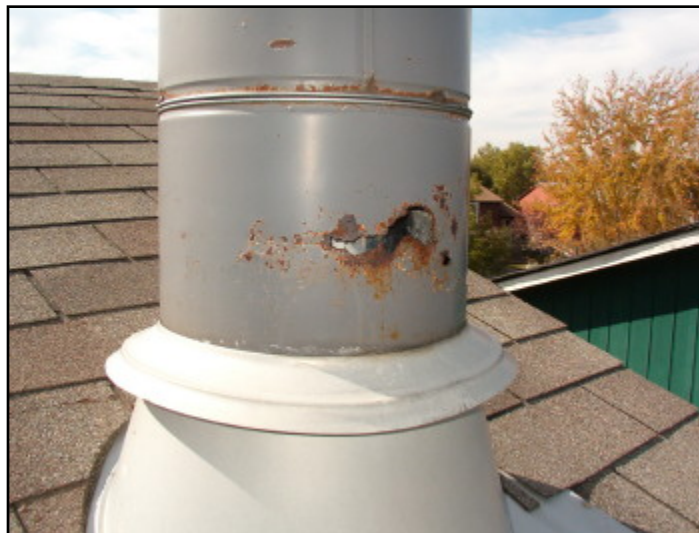
Condition: • [Chimney walls rusting or pitting](#)

Implication(s): Chance of movement | Hazardous combustion products entering home

13. Rusted chimney wall from fireplace

Task: Replace

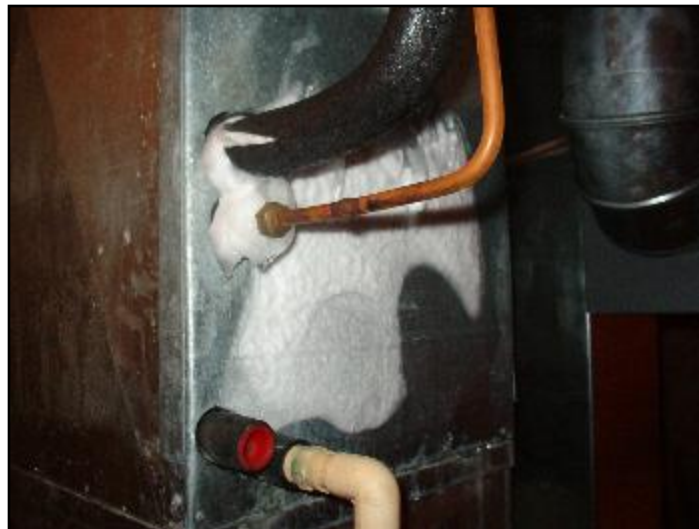
Condition: • [Frost](#)

14. Frost visible on ductwork at AC coil

Task: Repair

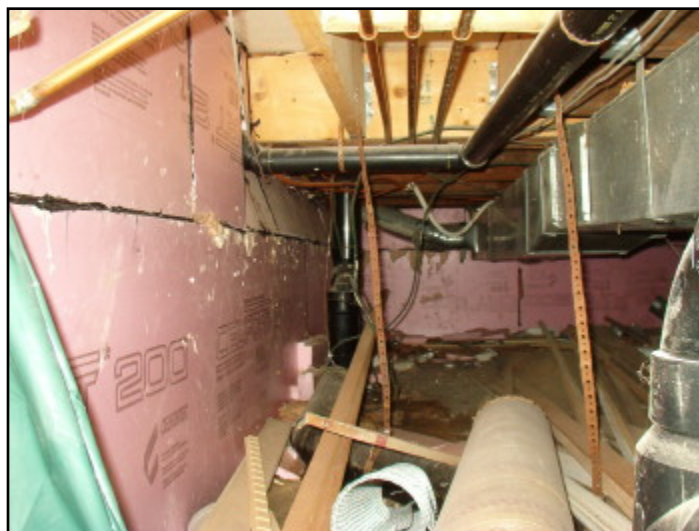
Condition: • [Exposed combustible insulation](#)

Implication(s): Fire hazard

15. Exposed polystyrene insulation is fire hazard

Task: Remove or cover with drywall

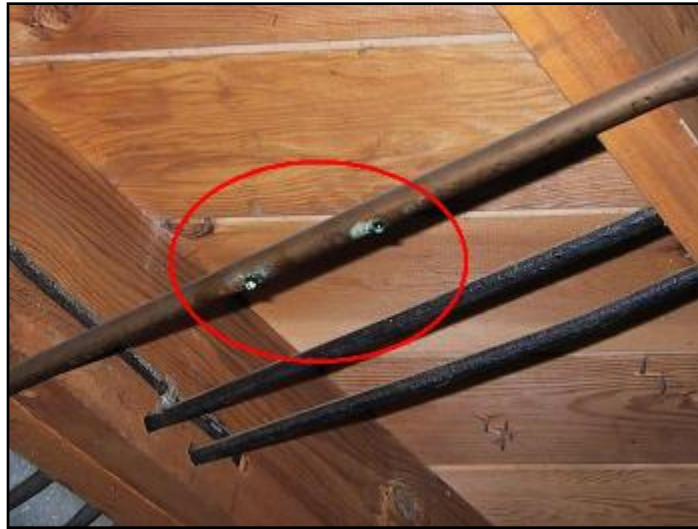
Condition: • [Leak](#)

Implication(s): Chance of water damage to contents, finishes and/or structure | System inoperative

16. Leaking copper supply pipe

Task: Repair

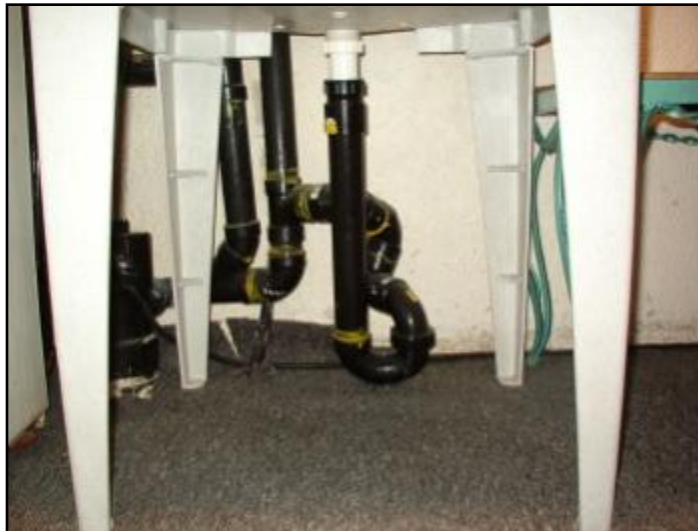
Condition: • [Nonstandard shape or material](#)

Note: This configuration is prone to clogging problems

17. Poor trap arrangement

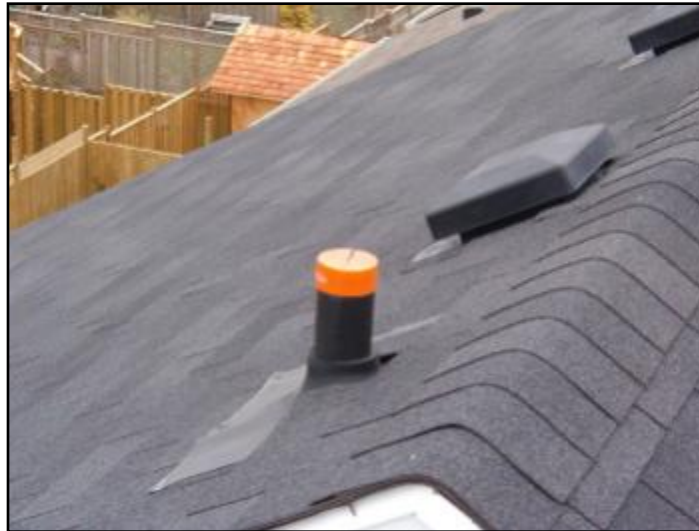
Condition: • [Vent termination problems](#)

18. Plumbing stack is capped

Task: Remove cap

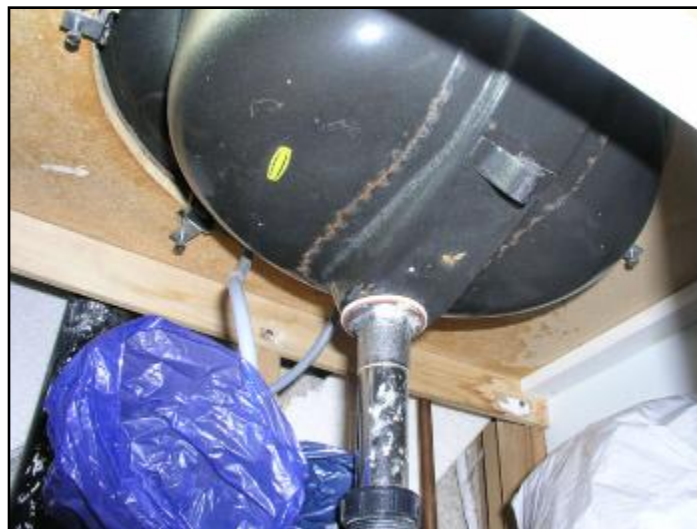
Condition: • [Rust](#)

Implication(s): Cosmetic defects | Chance of water damage to contents, finishes and/or structure

19. Steel basin rusting at weld

Task: Replace

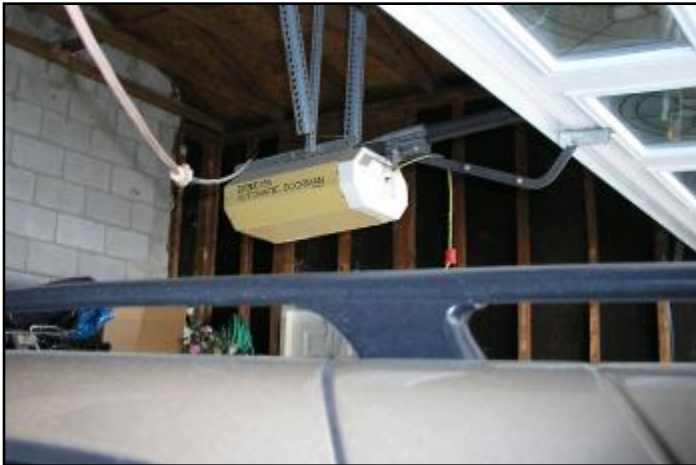
Condition: • [Extension cord for opener](#)

20. Extension cord for west garage door opener

Task: Replace with permanent wiring

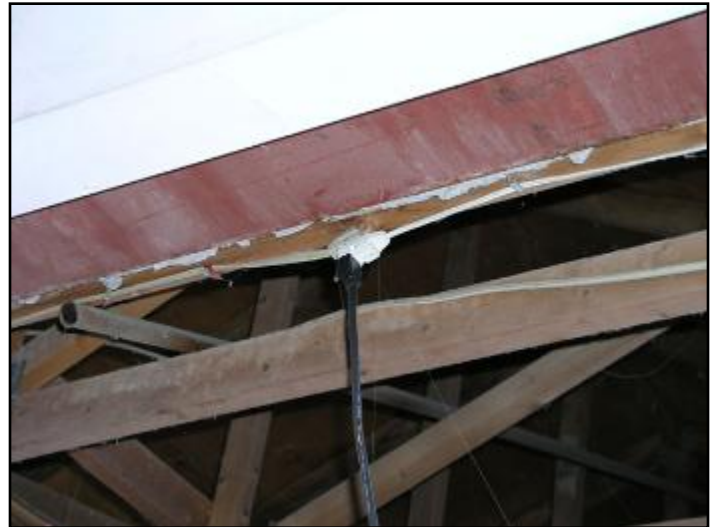
21. Extension cord for east garage door opener

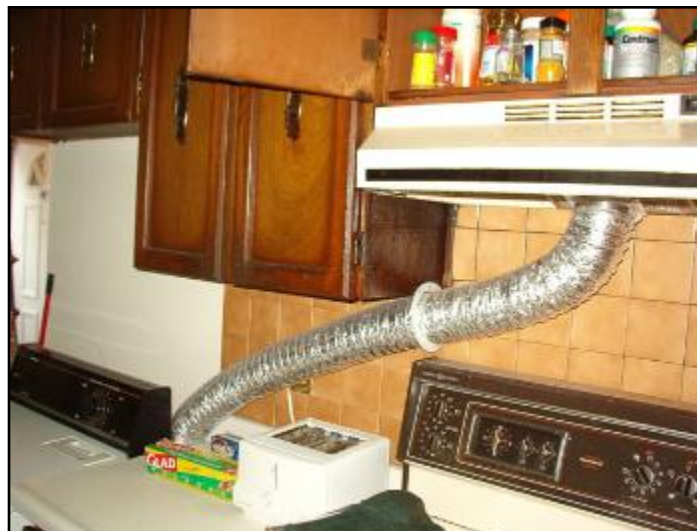
Condition: • The clothes dryer is vented into an exhaust fan designed for a stove. This unconventional installation should be re-arranged.

22. Clothes dryer vented incorrectly

Task: Improve
