INSPECTION REPORT

For the Property at:
27 MAPLE CRESCENT
CHICAGO, IL

Prepared for: JOHN SIMPSON
Inspection Date: Saturday, December 16, 2006
Prepared by: Alan Carson

RE: Report No. 1366
27 Maple Crescent
Chicago, IL

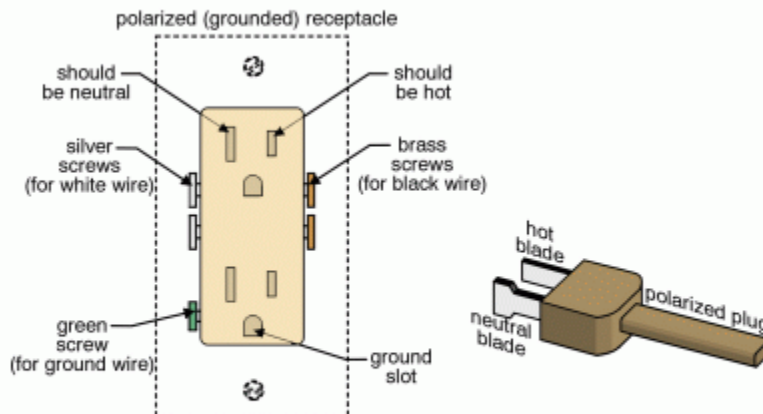
Distribution system \ Outlets**Condition:** • [Reversed polarity](#)**Implication(s):** Electric shock**Location:** Various**Task:** Correct**Time:** Less than 1 year**Reversed polarity**

when the polarity is reversed, the wide receptacle slot is (incorrectly) hot and the narrow slot is neutral - this is not uncommon when people forget that the black wire should be attached to the receptacle's brass screws

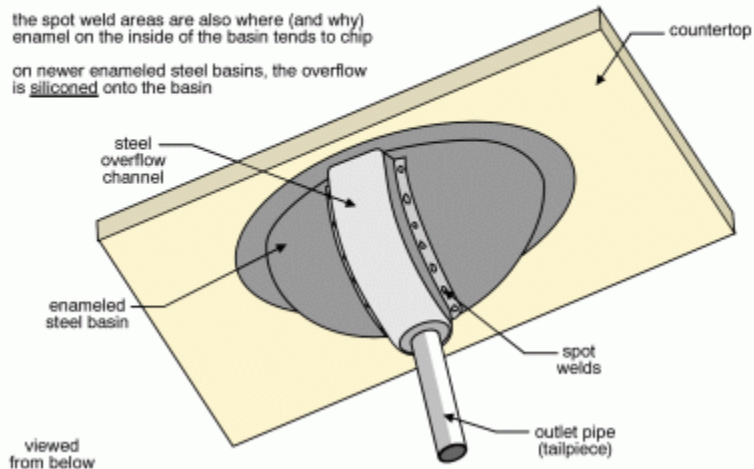
Fixtures and faucets \ Basin, sink and laundry tub

Condition: • [Rust](#)

the spot weld areas are also where (and why) enamel on the inside of the basin tends to chip

on newer enameled steel basins, the overflow is siliconed onto the basin
