YOUR INSPECTION REPORT

658 Clarke Rd
Coquitlam , BC

Monday, April 20, 2015

RE: Report No. 2583
658 Clarke Rd
Coquitlam , BC

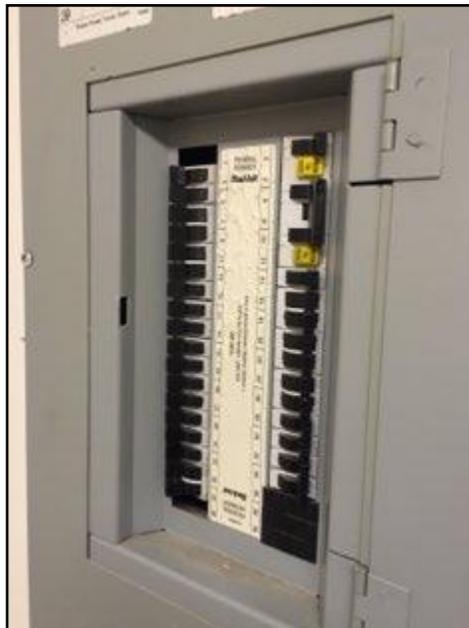
5. Condition: • [Openings in panel](#)

Implication(s): Electric shock | Fire hazard

14. Openings in panel

Task: Repair

Time: Immediate

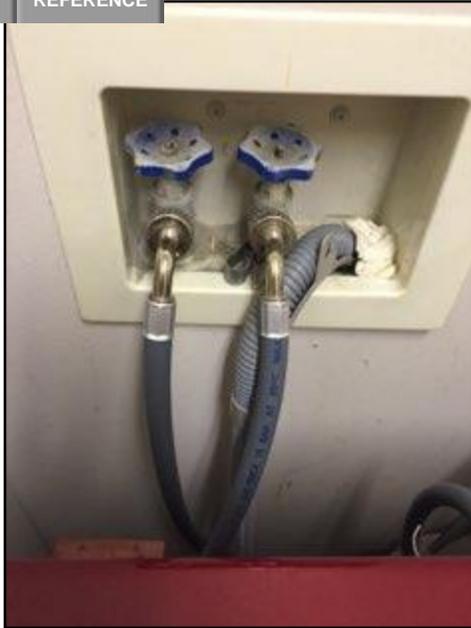
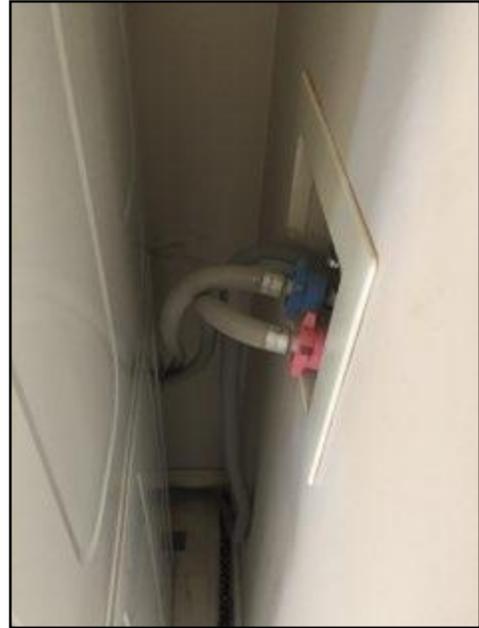
29. Install steel braided supply lines to...

30. Install steel braided supply lines to...

12. • Install steel braided supply lines to washer. Rubber hoses can burst at any time as they age. Water damage and or extra costs can occur.

Time: Immediate

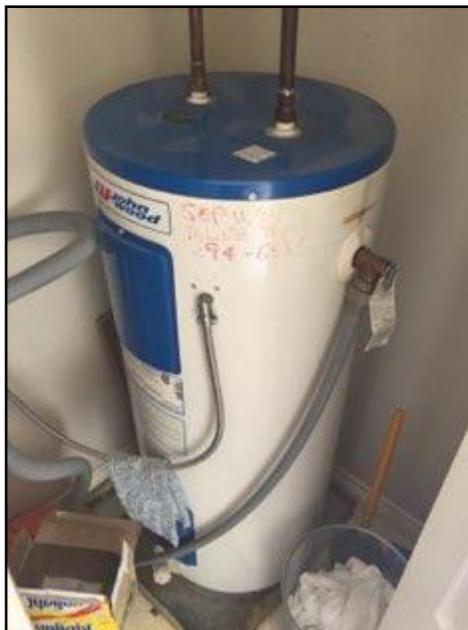
13. Condition: • [Old](#)

31. Old

Task: Monitor

Time: Ongoing

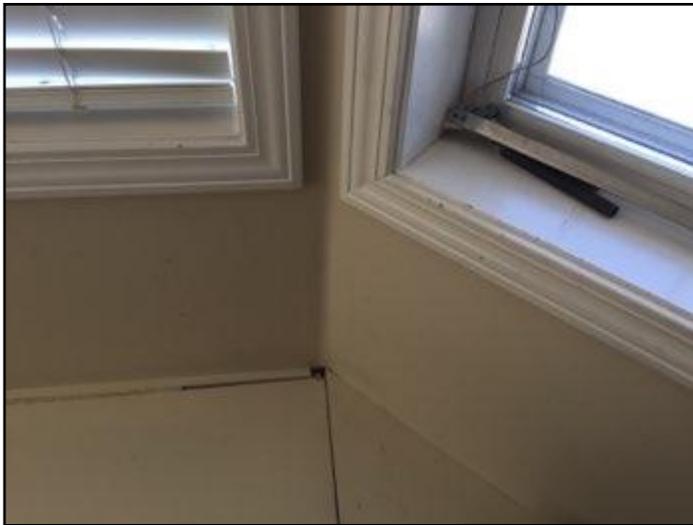
44. Service sealants

Task: Service

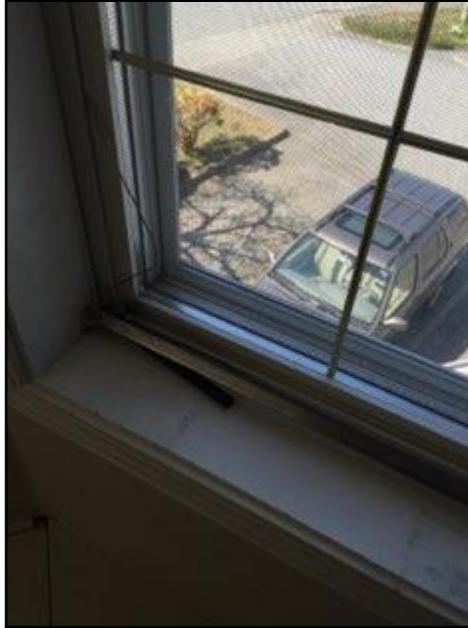
20. Condition: • [Inoperable](#)

54. Inoperable

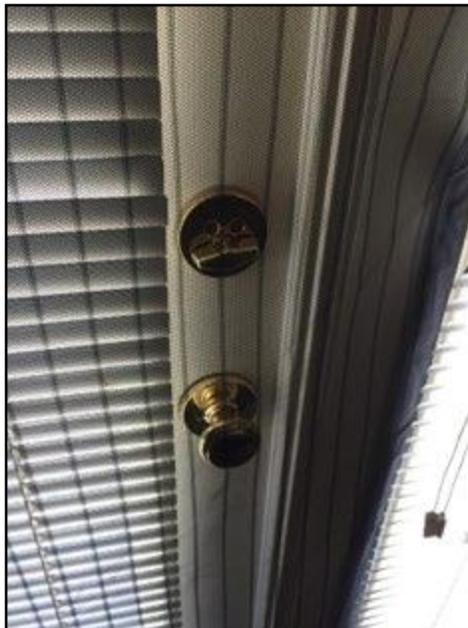
24. Condition: • [Inoperable](#)

58. Inoperable

Task: Service

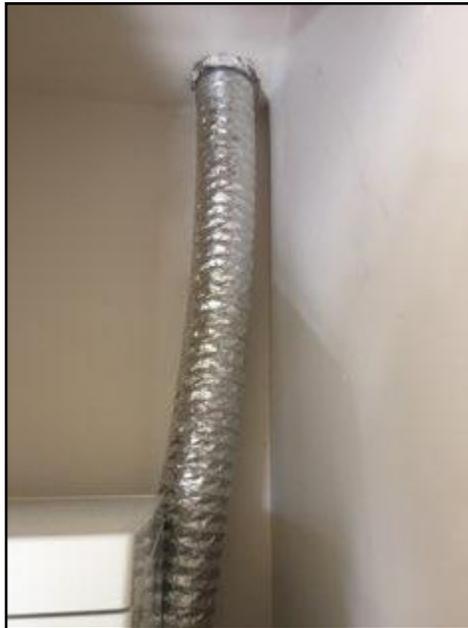
26. Condition: • Dryer vent material not smooth wall

60. Dryer vent material not smooth wall

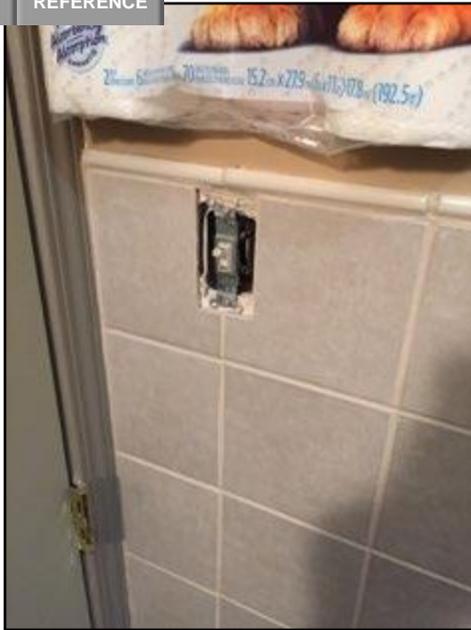
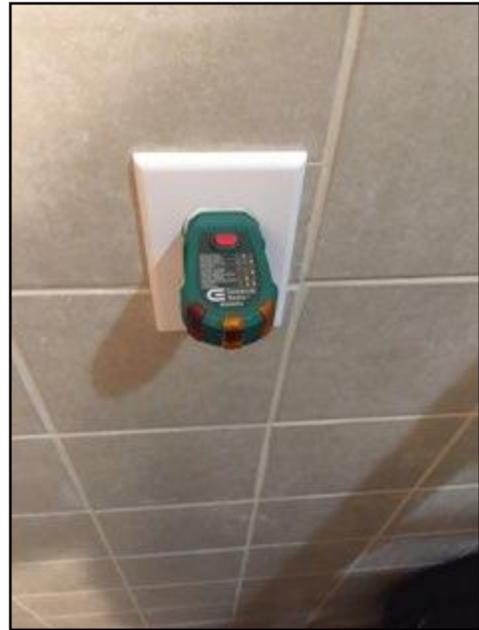
33. Condition: • Missing cover plate. Outlet does not work.

Task: Repair

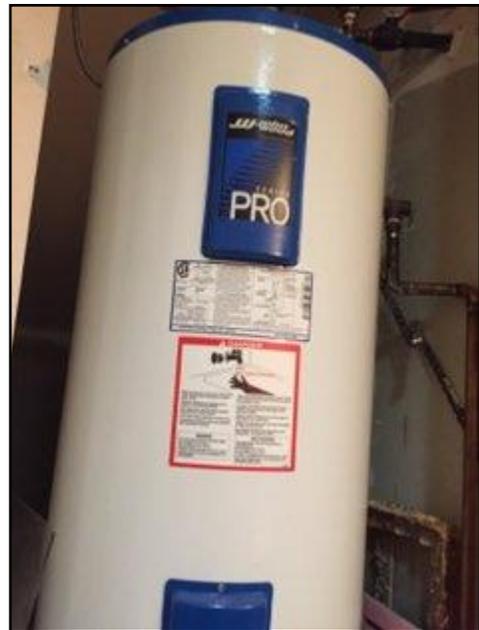
44. Condition: • Approaching the end of its expected useful life

92. Approaching the end of its expected useful...

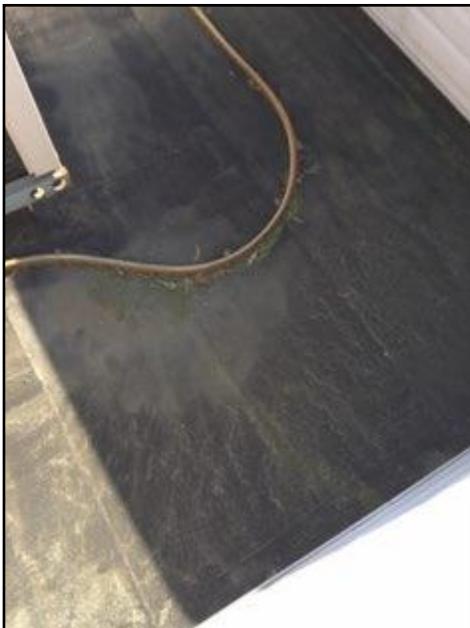
94. Flat roof(s)

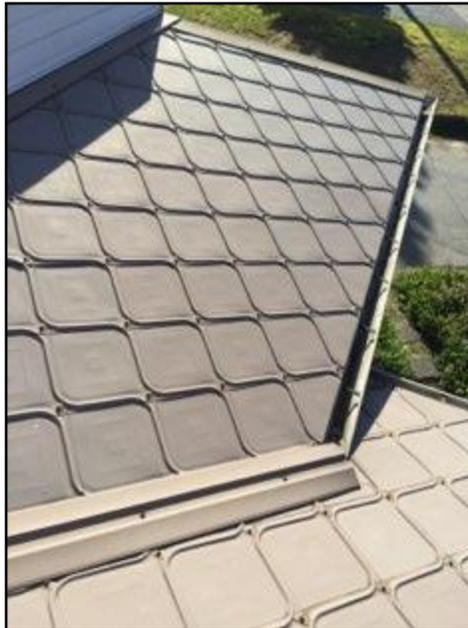
100.

Implication(s): Damage to building can occur or occupants. Extra costs can occur

Task: Further evaluation

Time: Immediate

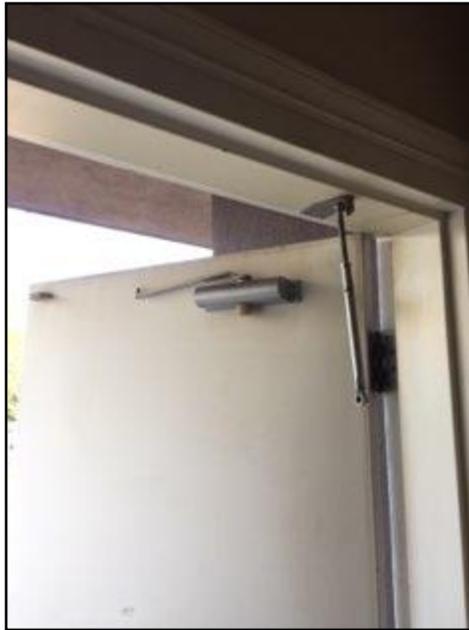
128.

55. • No deadbolt for exterior door

Task: Improve

Time: Immediate

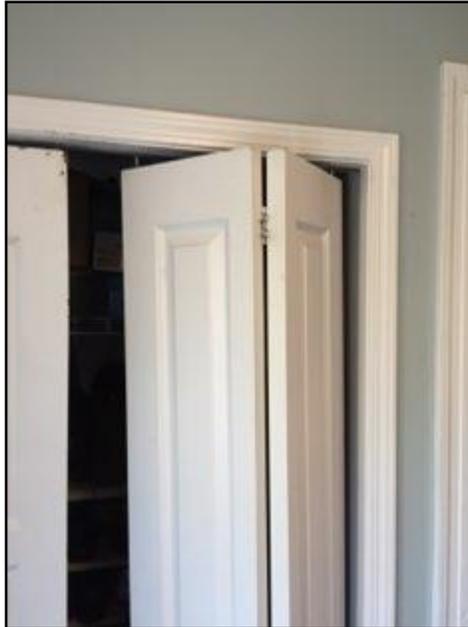
130.

59. **Condition:** • Fire separation and combustion gases not complete

Implication(s): Fire hazard and life safety issue

Task: Repair

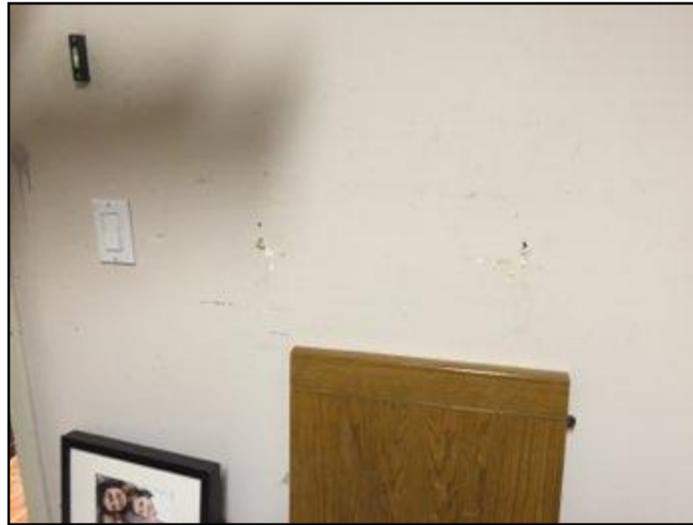
131.

60. Condition: • Water stain

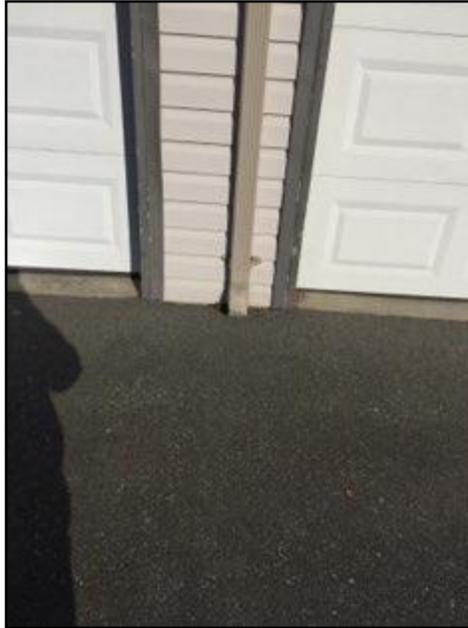
146.

66. • Missing door threshold

Implication(s): Damage can occur from water or animal access

Task: Improve

Time: Immediate

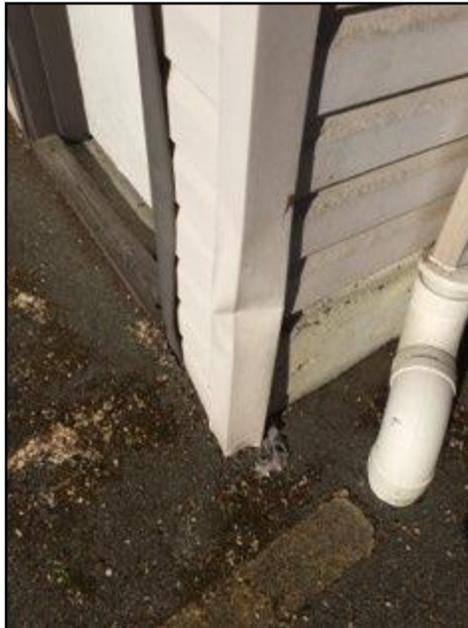
156. No major deficiencies noted

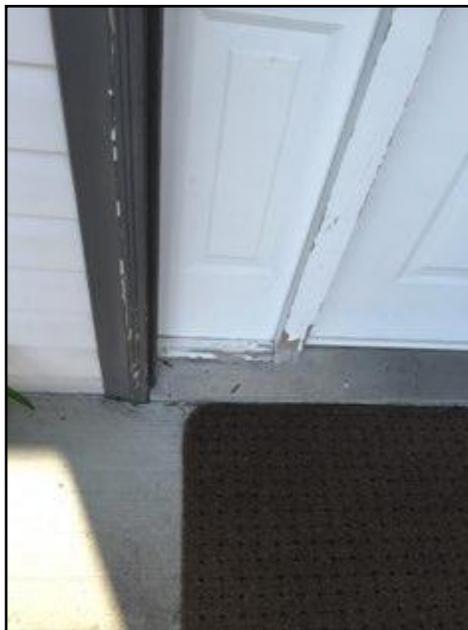
160.

72. Condition: • Painting needed

Implication(s): Extra costs can occur/ water damage

Task: Service

Time: Regular maintenance

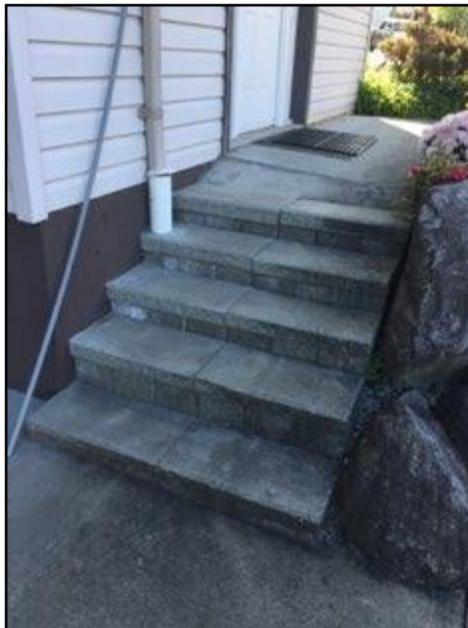
163.

74. Condition: • Missing railing

Implication(s): Safety hazard

Task: Repair

Time: Immediate

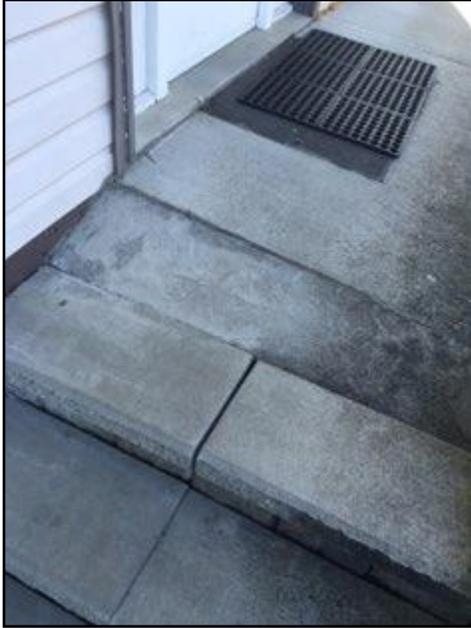
164.

EXTERIOR REFERENCE hazard

Implication(s): Safety issue
Location: Right Side Exterior
Task: Improve
Time: Immediate
